PERATION

GREENHOUSE

SCIENTIFIC DIRECTOR'S REPORT

ANNEX 3.2 U. S. NAVY STRUCTURES

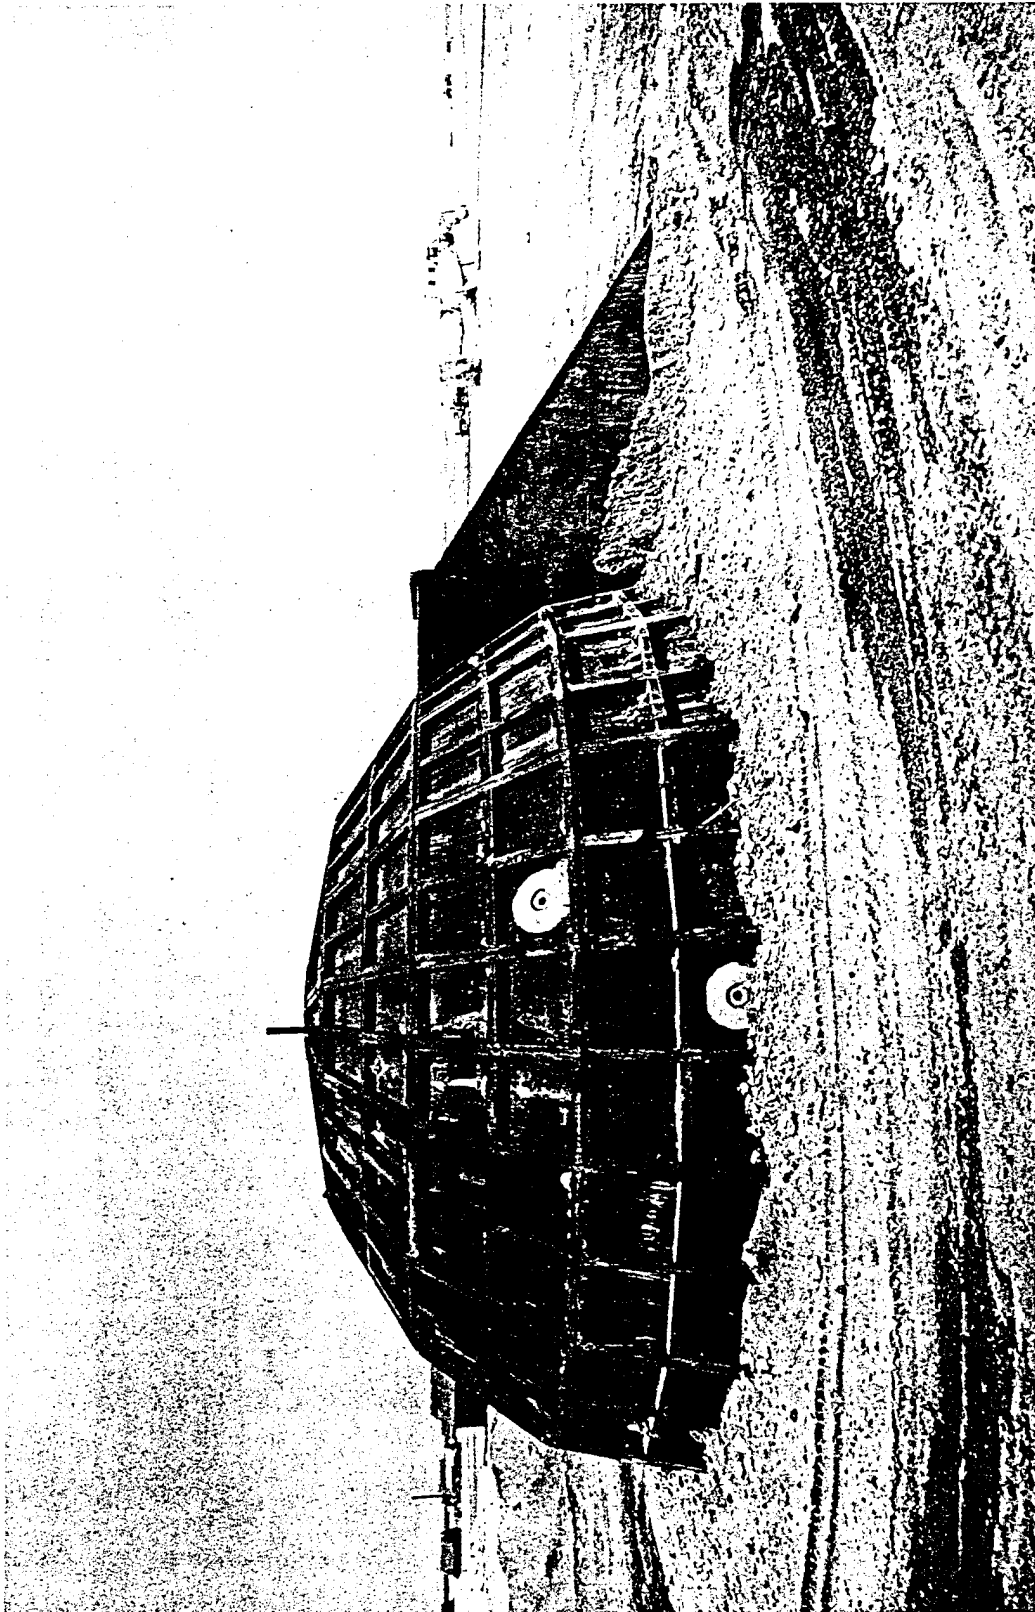
Fig. L. 440 Structure 3.2.6, Uncovered from the Front

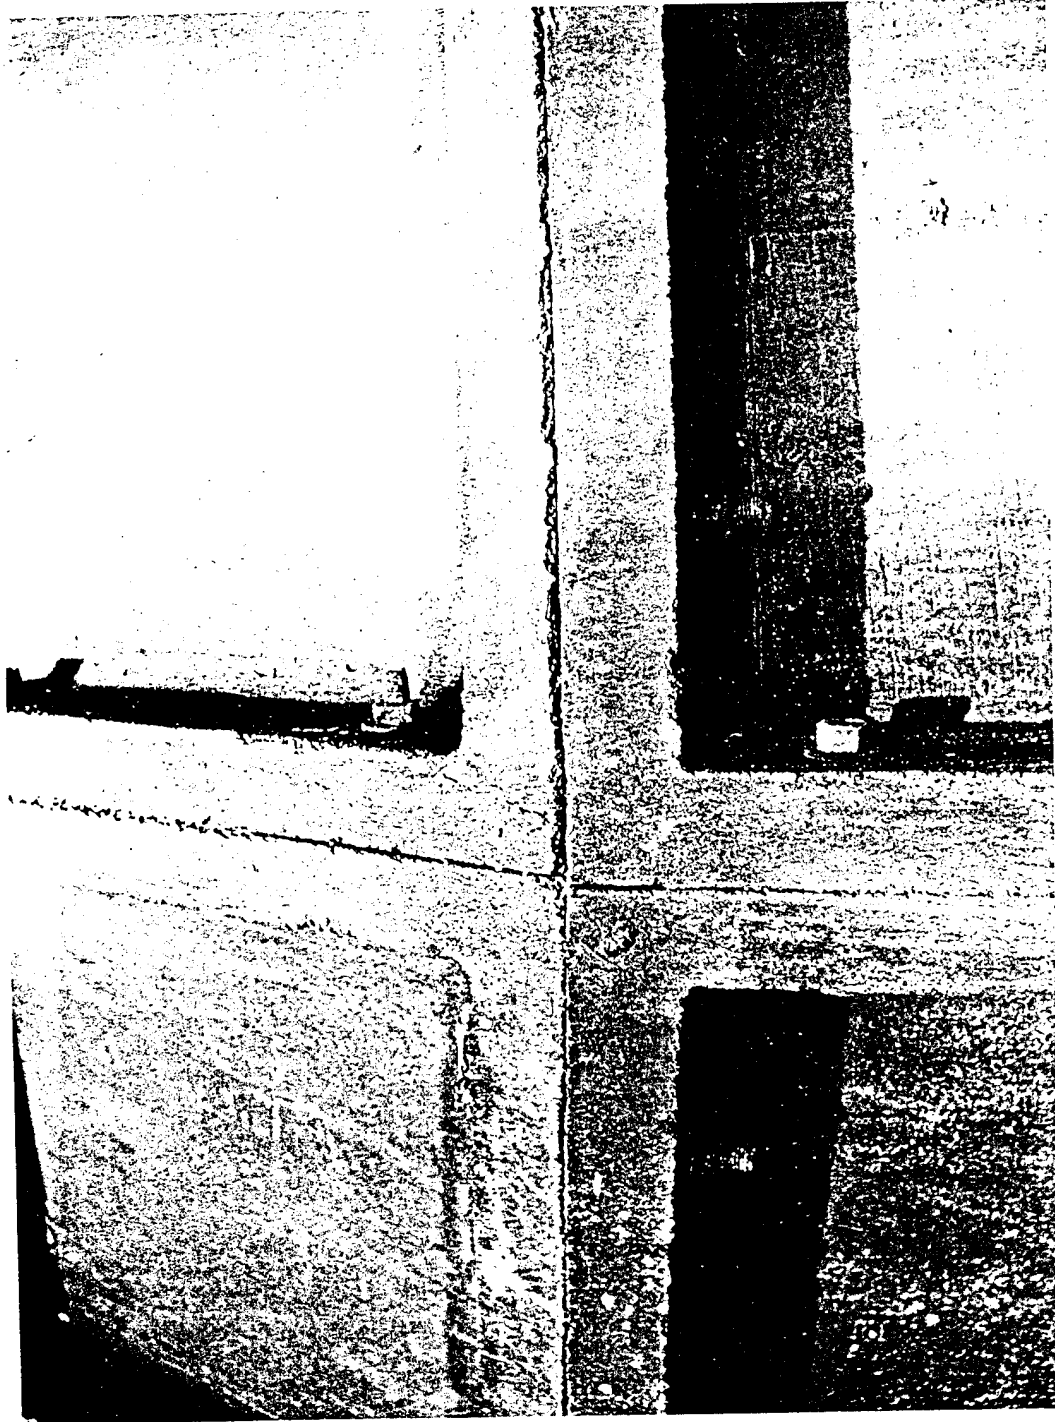
Fig. L. 441 Detail of Typical Rib Intersection Crack, Structure 3.2.6

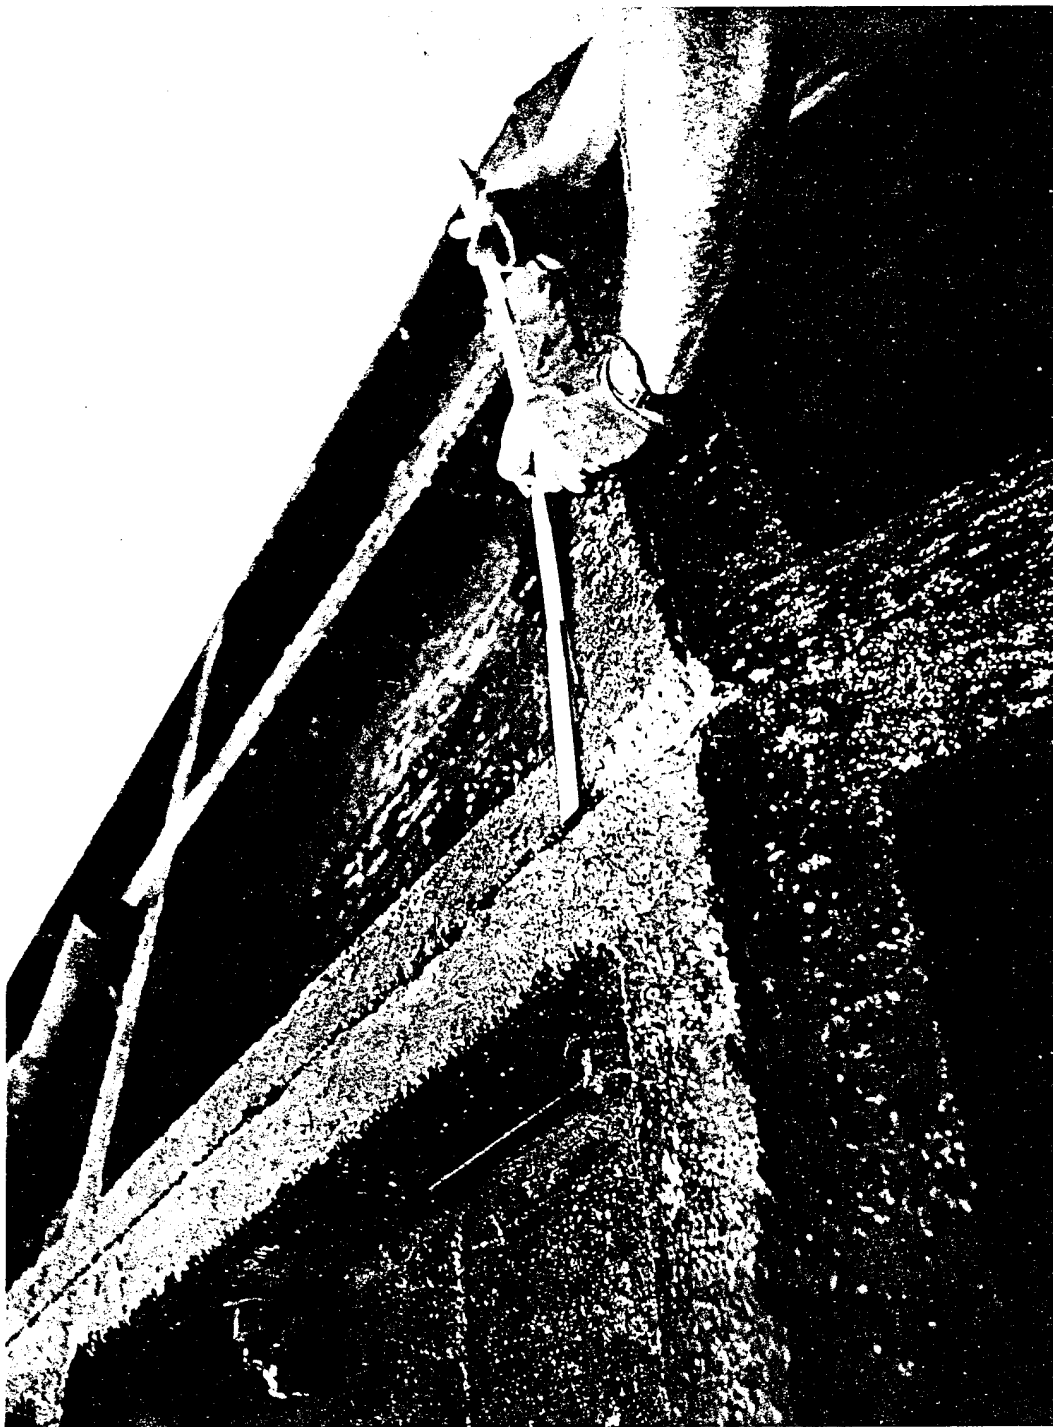
Fig. L.442 Detail of Typical Rib Intersection Spall, Structure 3.2.6

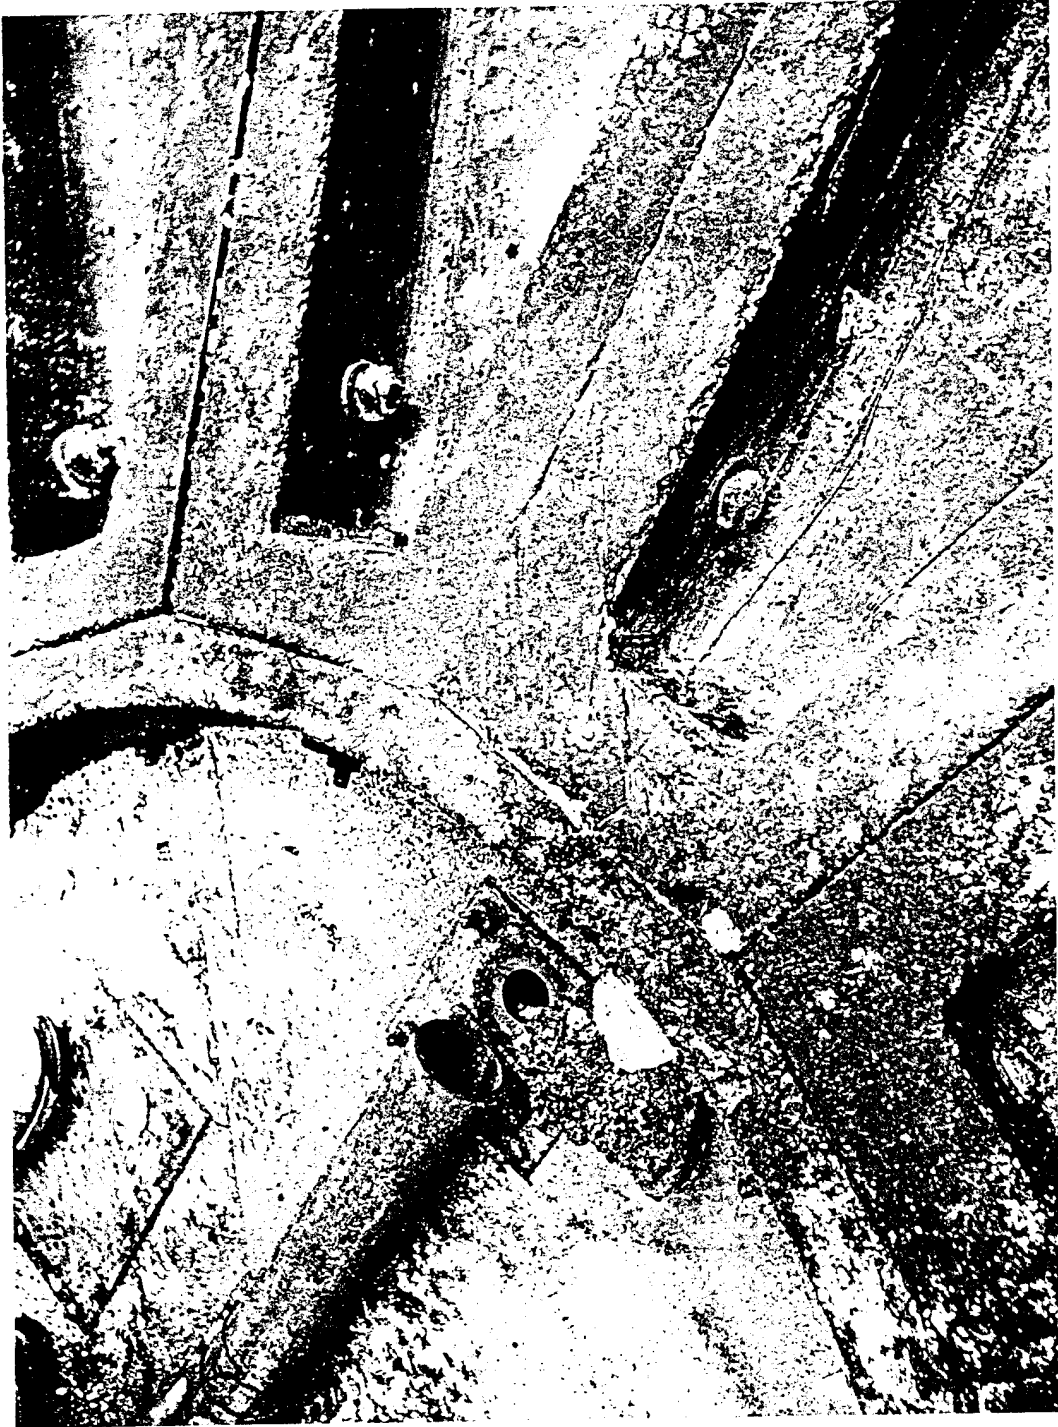
Fig. L. 443 Detail of Top Panel Intersection, Structure 3.2.6. Hinged pipe at left center carried through earth cover to air-pressure gauge installed in the end of the pipe.

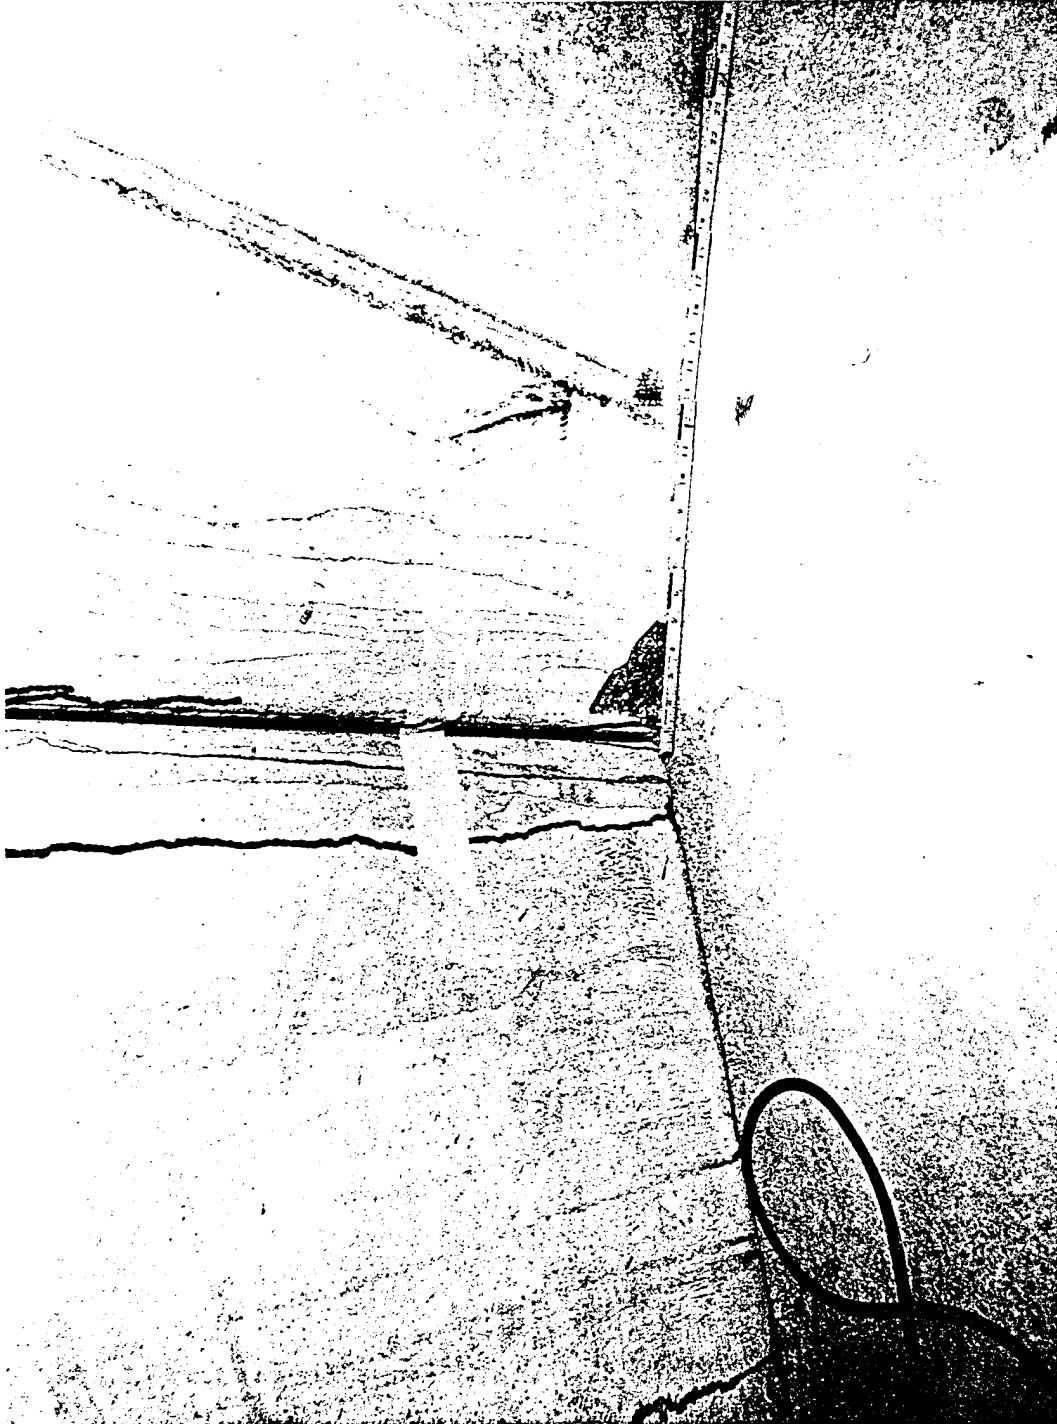
Fig. L.448 Typical Detail of Spall at Corners in Base of D Ring, Structure 3.2.6

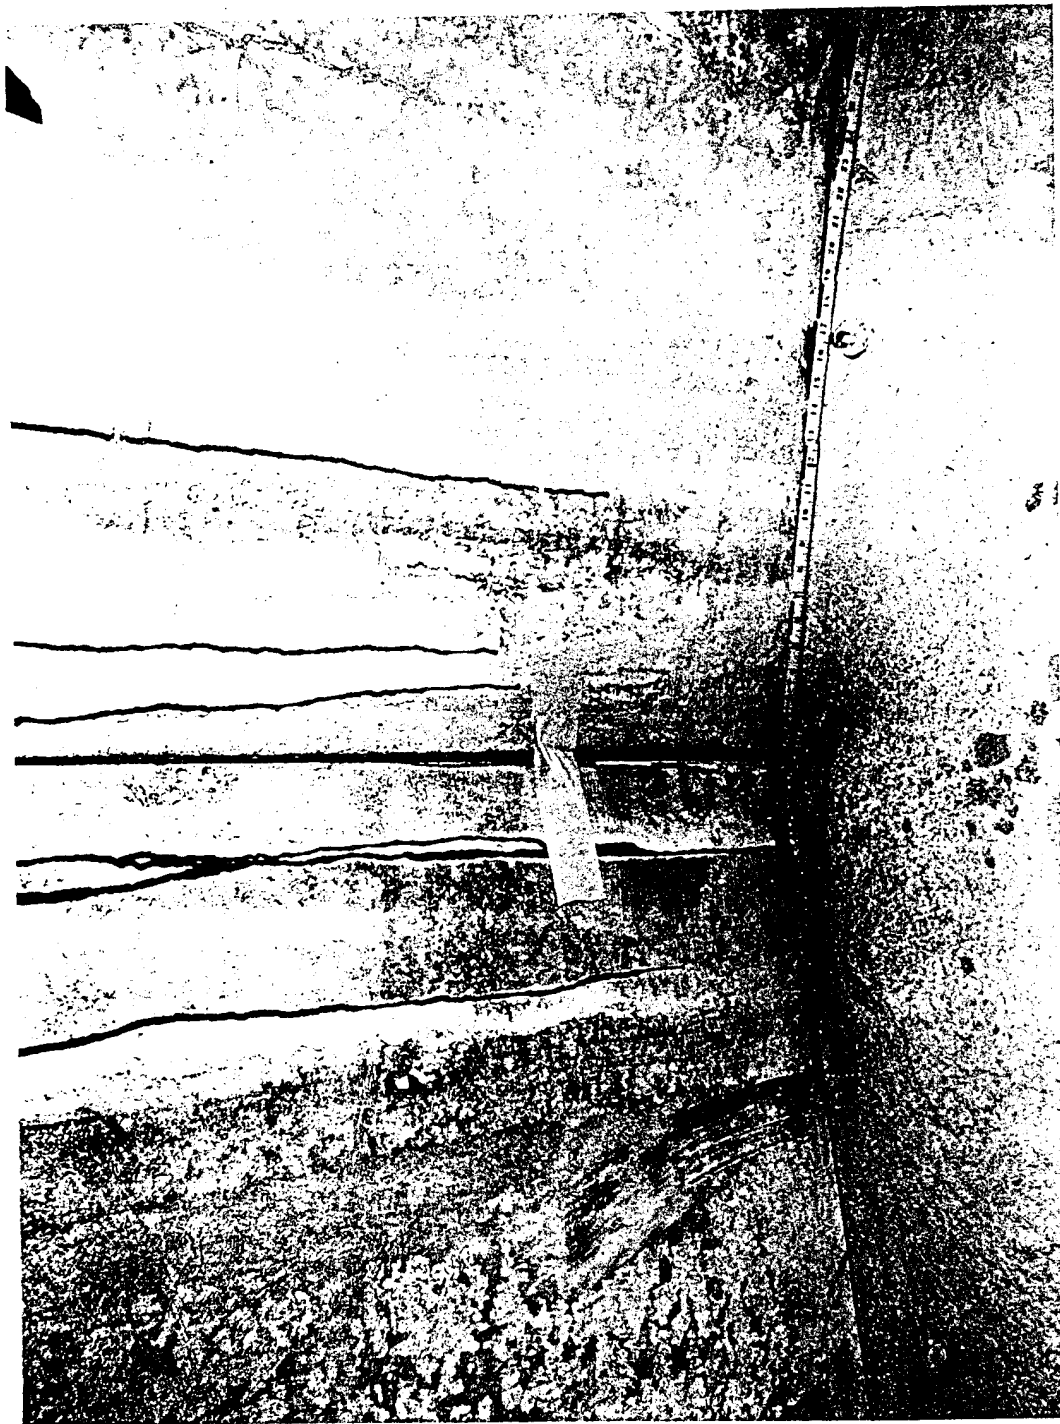
Fig. L. 449 Typical Detail of Spall and Cracks in Base of D Ring, Structure 3.2.6. Tape shows relative movement of panels.

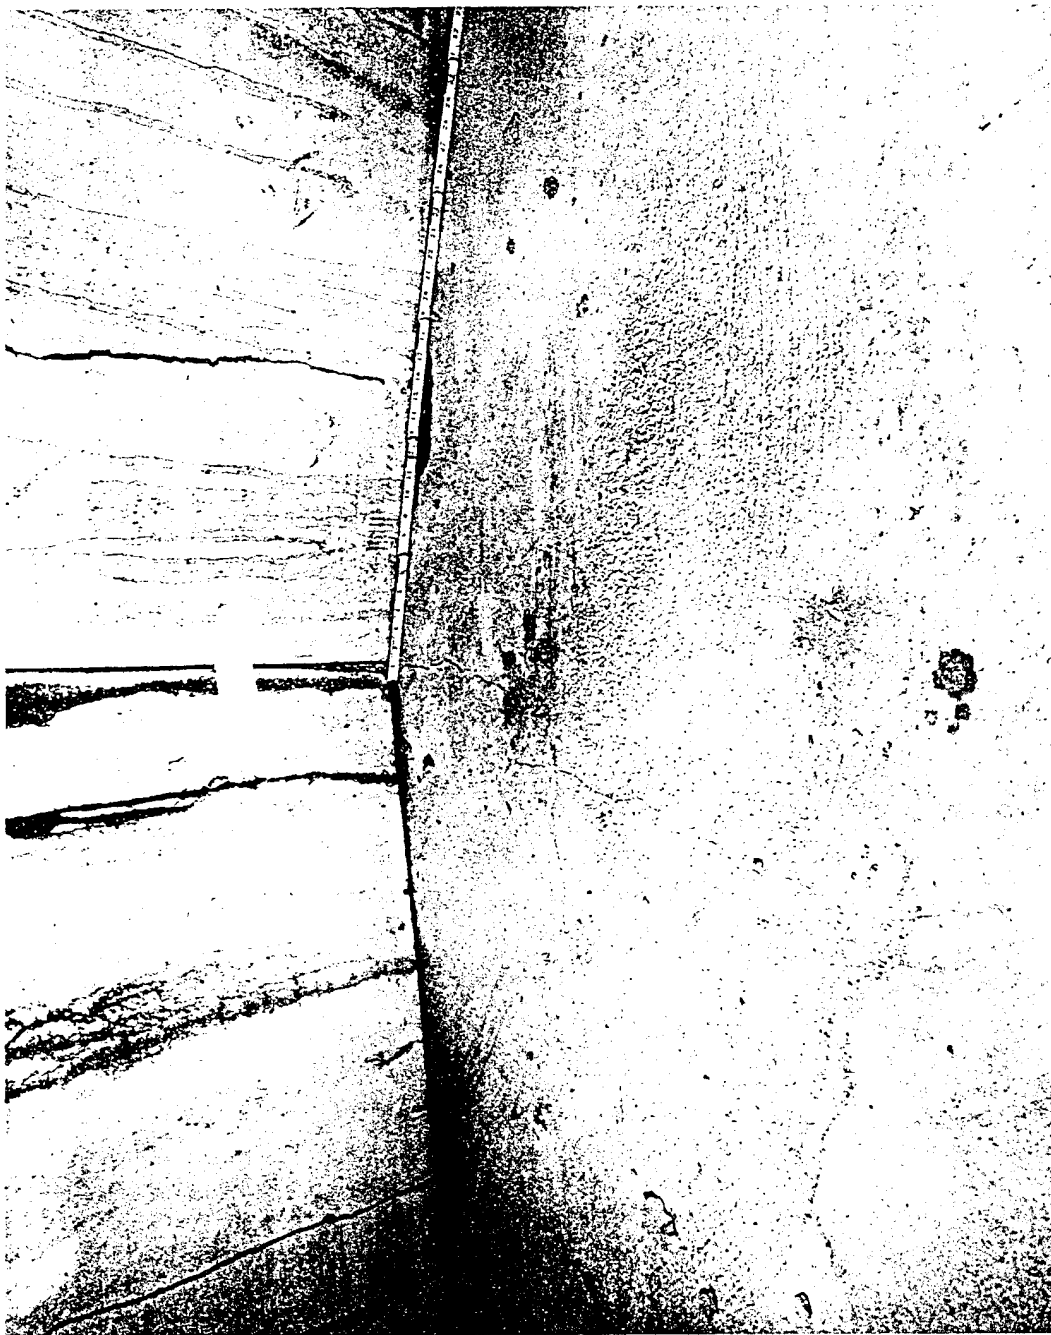
Fig. L. 450 Radial Crack in Floor of Building on Side Opposite Wing Walls, Structure 3.2.6

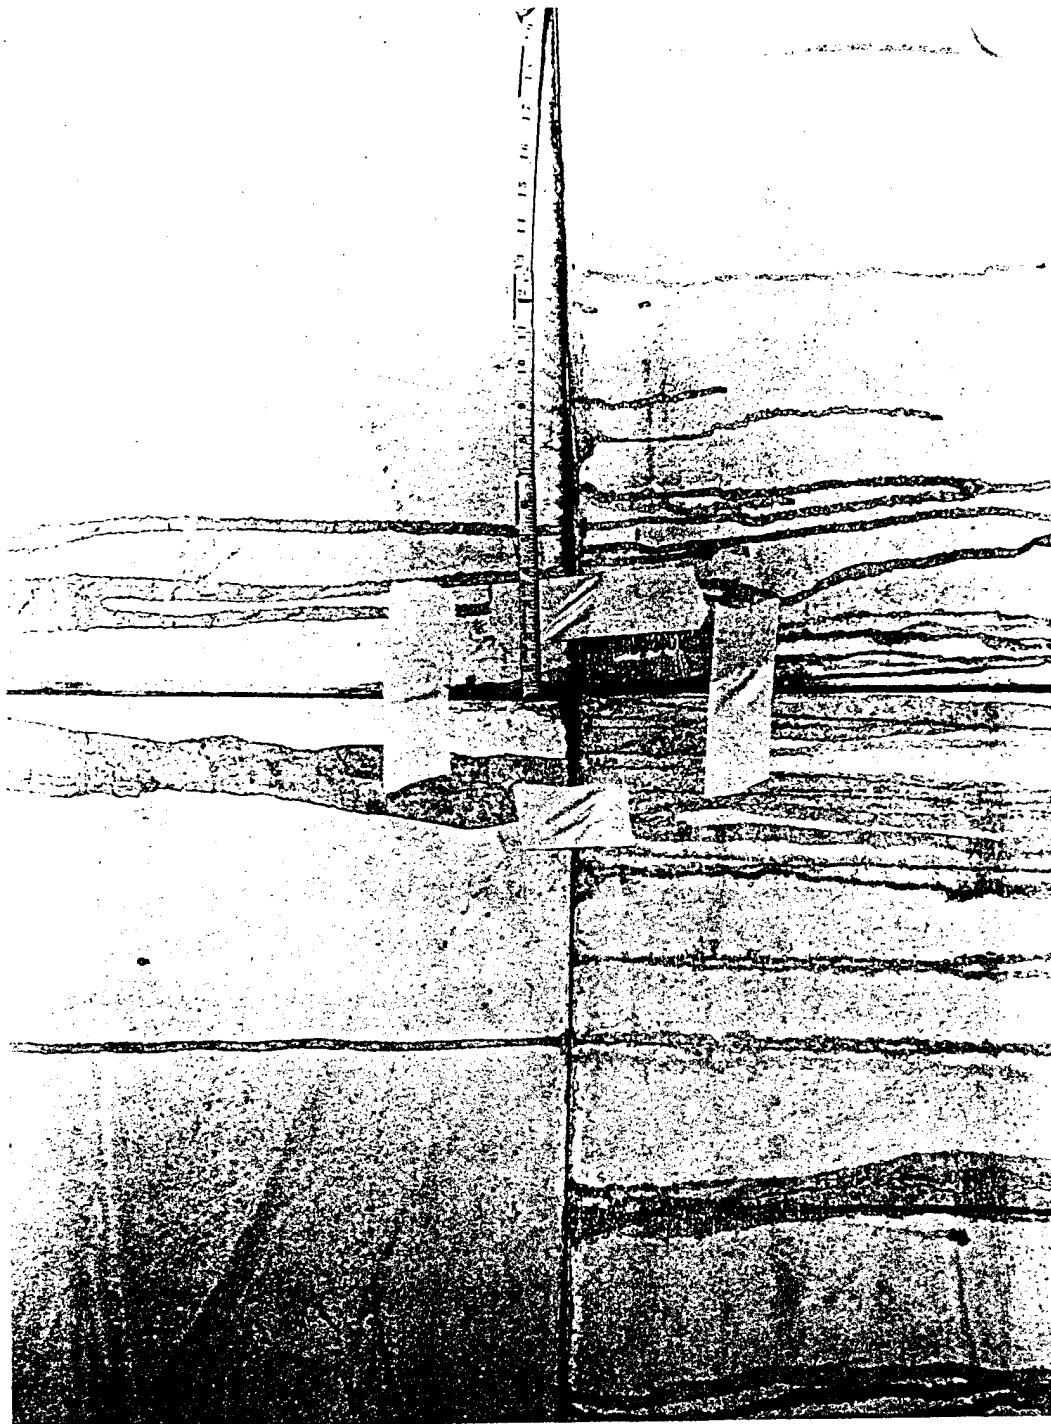
Fig. L.451 Typical Tape Buckling Showing Relative Movement of Panels, Structure 3.2.6

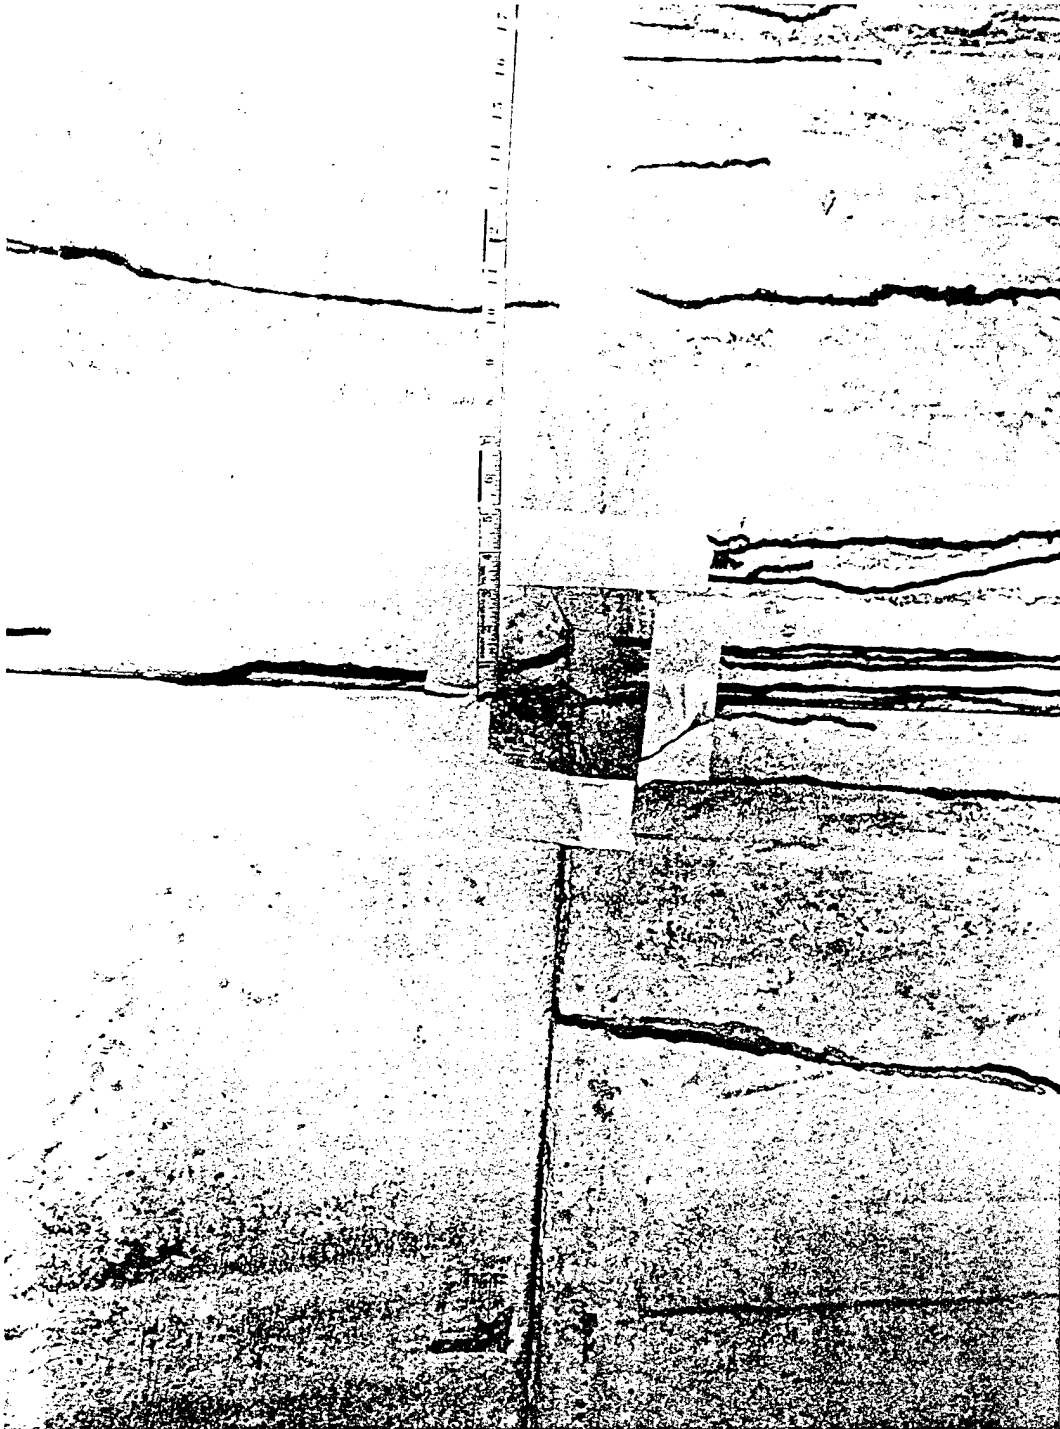
Fig. L. 452 Typical Spall at Corner Intersection of D and C Ring Panels, Structure 3. 2. 6

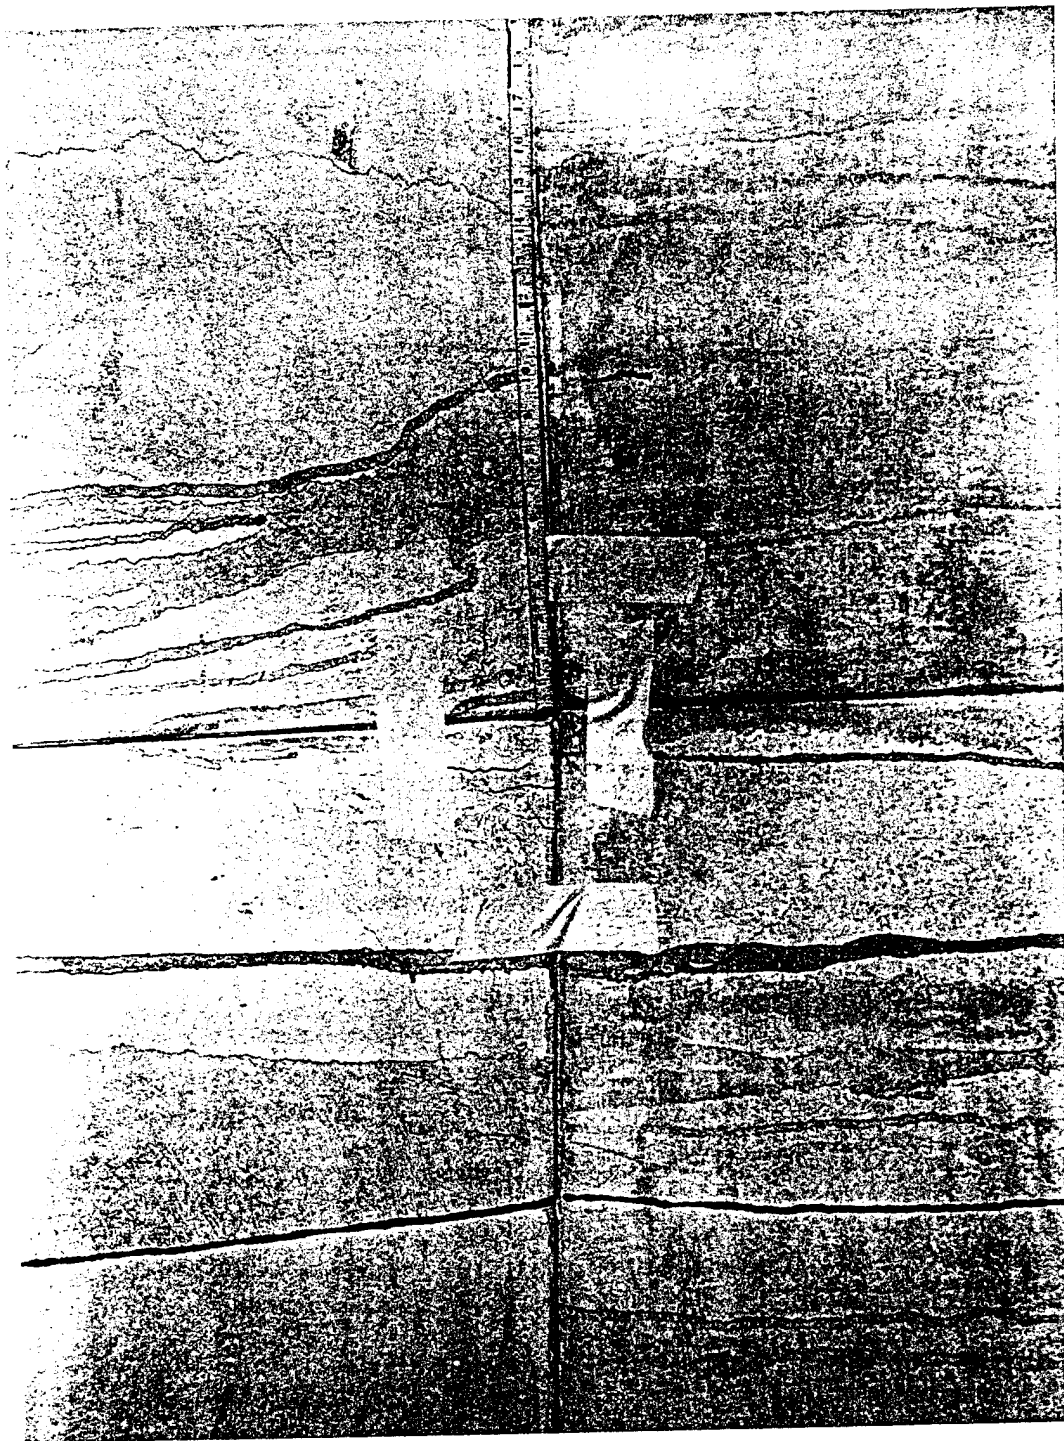
Fig. L. 453 Typical Vertical Cracks at Corner Intersection of D and C Ring Panels near Front, Structure 3.2.6

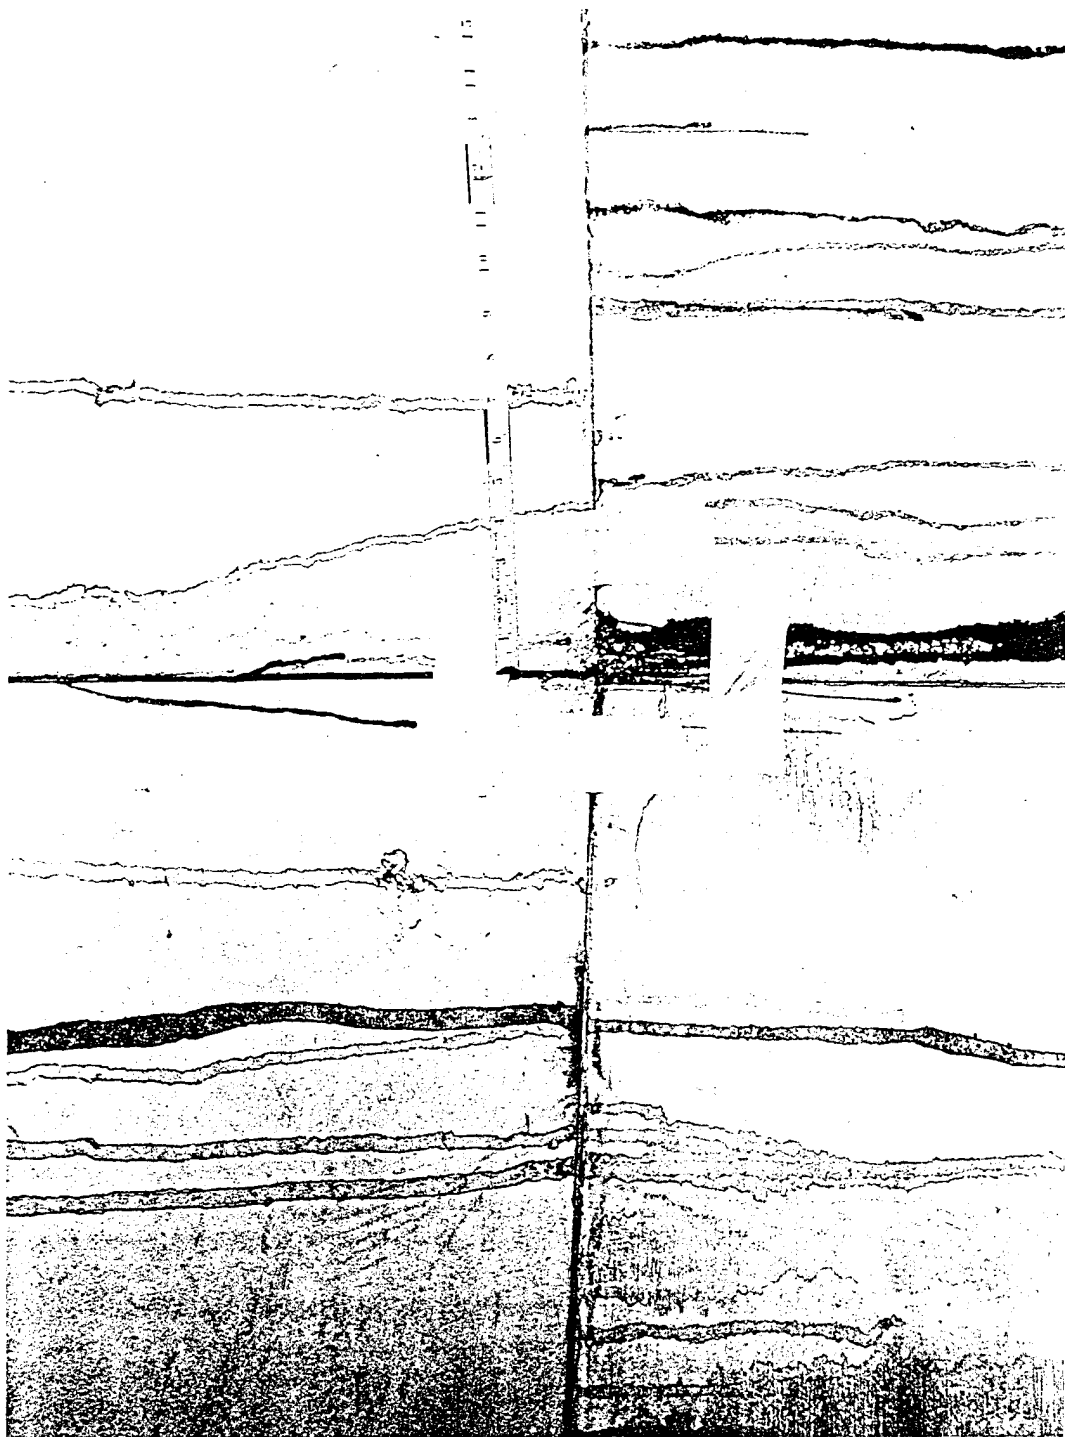
Fig. L. 454 Typical Horizontal Cracks at Corner Intersection of D and C Ring Panels near Left, Structure 3.2.6

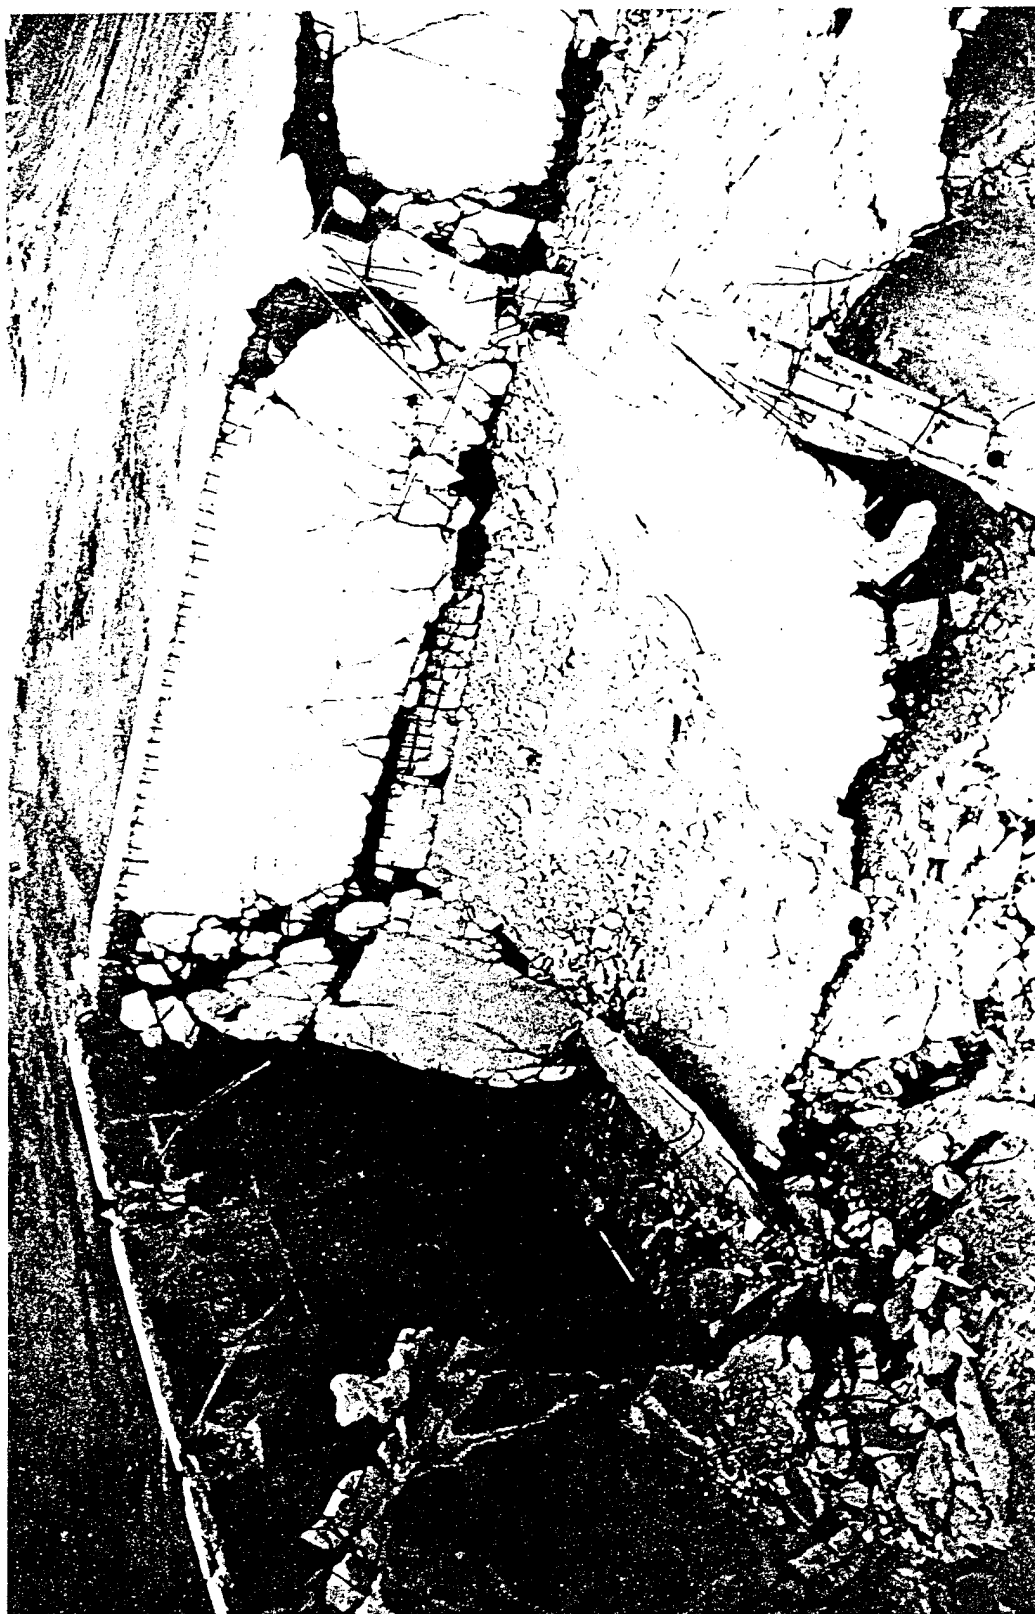
Fig. L.460 Left Section of Front Wall, Interior Left End Wall, and Roof, Structure 3.2.7a. Front wall lies partially under the roof.

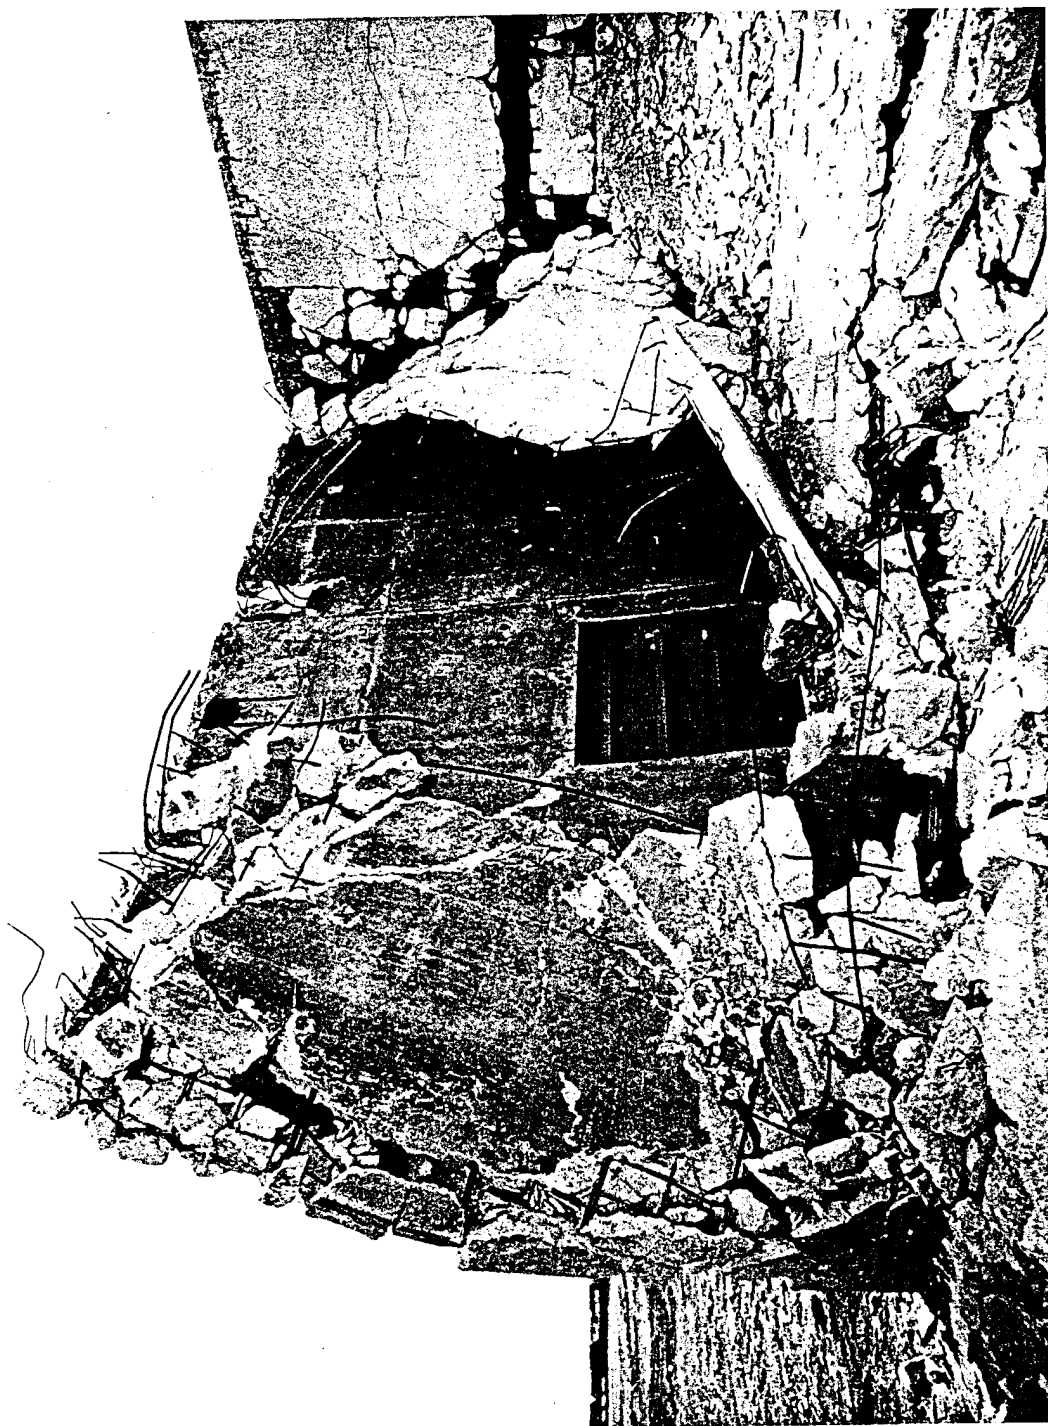
Fig. L.461 Left Corner of Front Wall Showing Corner and Front-wall Failure, Structure 3.2.7a

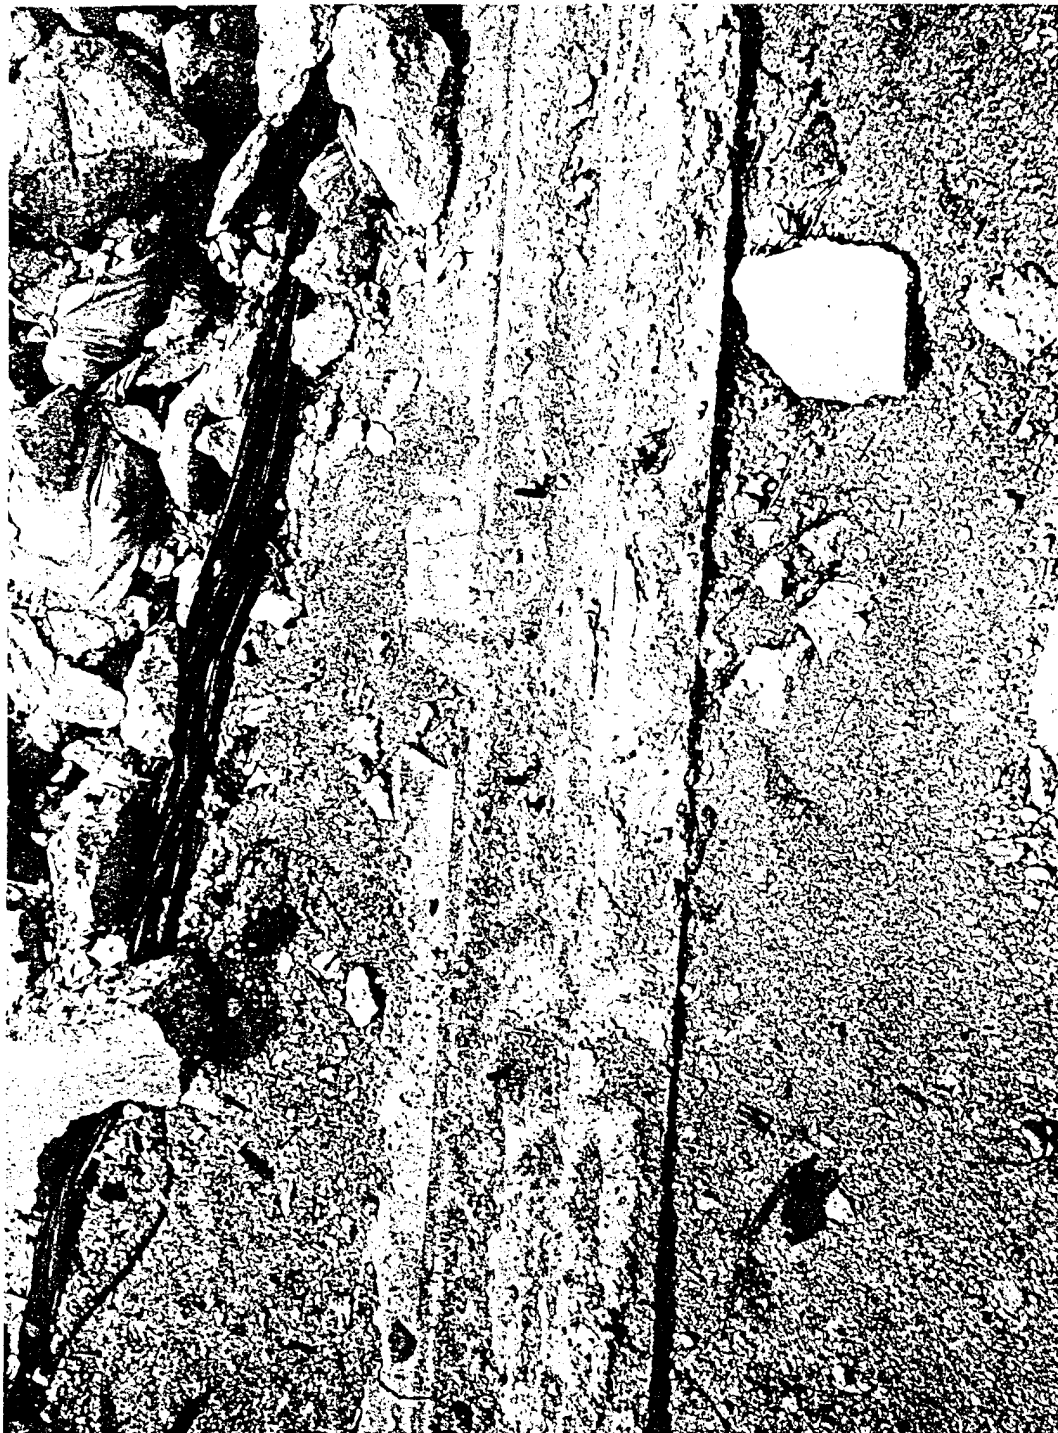
Fig. L. 462 Necked-down Steel Dowels in Front-wall Foundation, Structure 3.2.7a

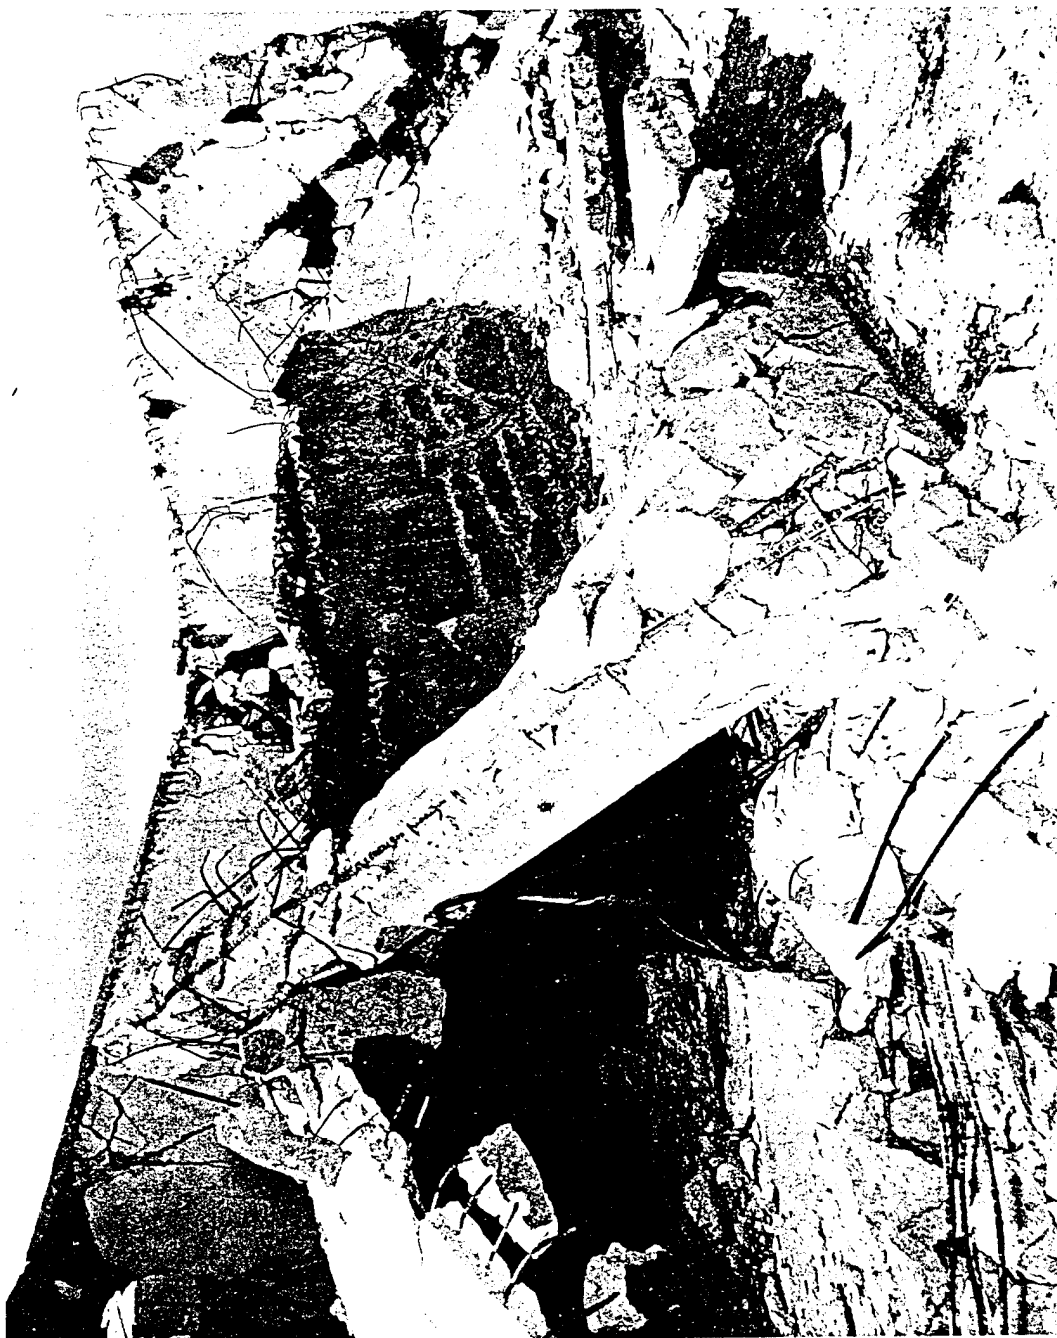
Fig. L. 464 Diagonal View of Right Half of Front Wall and Center Column, Structure 3.2.7a. Note deflection and compression spalls in front-wall slab. Note also the corner failure taking part of the end wall.
